Architectural Survey at Joint Base Langley-Eustis of Fort Eustis Buildings and Structures Built 1946–1975: Volume II (Inventory Forms)

Sunny E. Adams and Adam D. Smith

December 2015

Final report

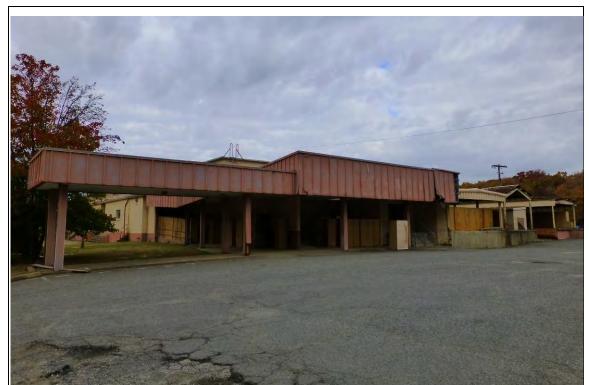
Photo 5. Building 1605, left side of the southeast elevation, metal canopy/loading dock addition (ERDC-CERL, 2013).

The overall massing (large structure, flat roof, one-story/high-bay) of Building 1605 is intact. The original long rectangular footprint has been enlarged with the addition of several metal canopies/loading dock/open-air storage located on the southeast side. Overall the style of the building is intact with few alterations and modifications to the building. The majority of the original construction materials (concrete block walls, loading docks, canopies, band of original steel-sash clerestory windows) are intact. Most of the original doors have been replaced.

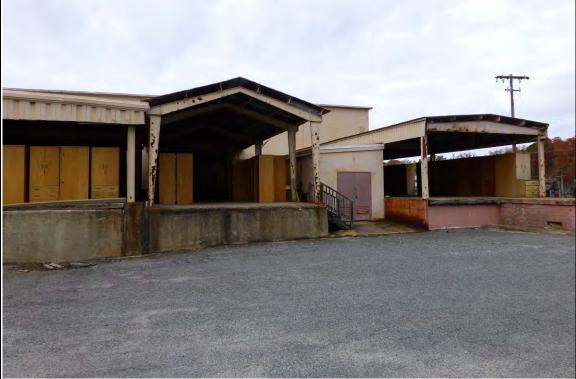
Photo 6. Building 1605, right side of the southeast elevation, metal canopy/loading dock addition (ERDC-CERL, 2013).

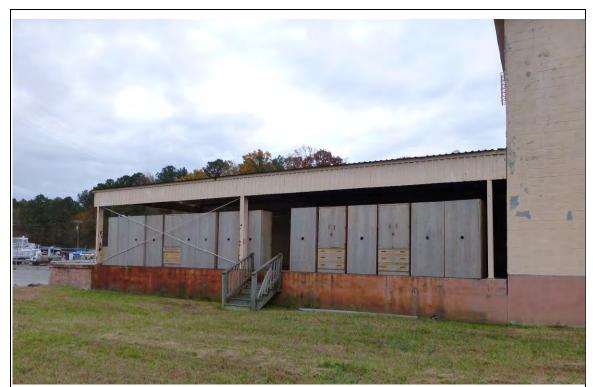
Photo 7. Building 1605, left side of the northeast elevation, metal canopy/loading dock addition (ERDC-CERL, 2013).

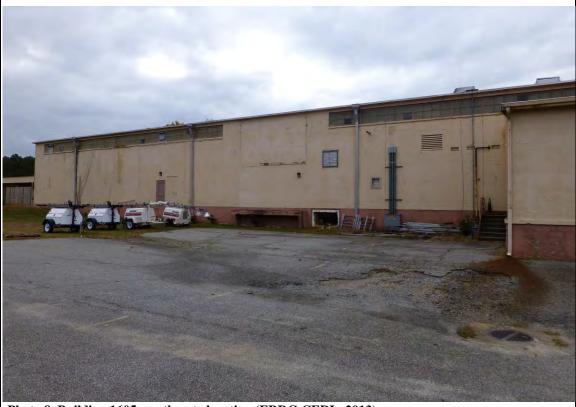
Photo 8. Building 1605, northeast elevation (ERDC-CERL, 2013).

The northeast elevation faces the railroad yard. A band of original metal-sash clerestory windows stretches across the top of the exterior wall. The band is broken up into three sections. On the left side of the elevation is a single-entry metal door and an original overhead garage door that has been removed and the opening filled with concrete block. Adjacent to this modification is a projecting concrete block appendage that has a raised concrete foundation, concrete block exterior walls and a metal shed roof. There is an overhead door on the northeast elevation of the appendage and a single-entry door and overhead metal door on the southeast elevation of the appendage. To the right of the appendage, the exterior wall consists of two overhead doors and a single-entry door. All the doors on this elevation are elevated due to the raised concrete foundation.

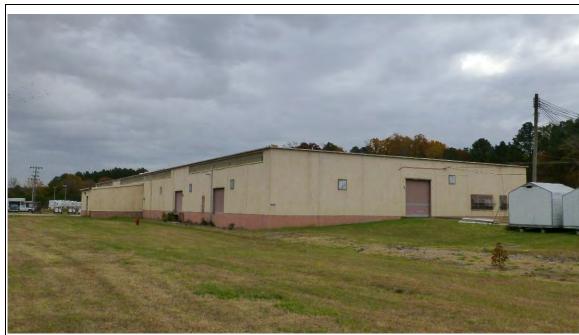
Photo 9. Building 1605, north oblique (ERDC-CERL, 2013).

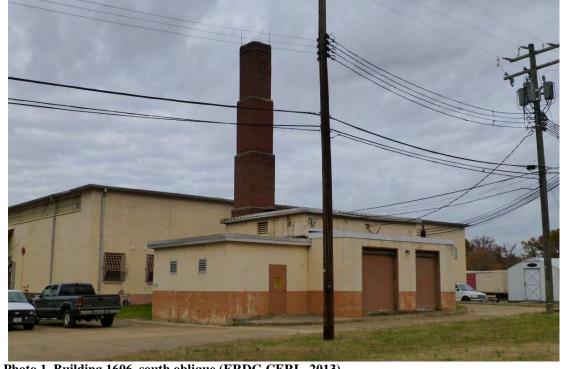
Photo 1. Building 1606, south oblique (ERDC-CERL, 2013).

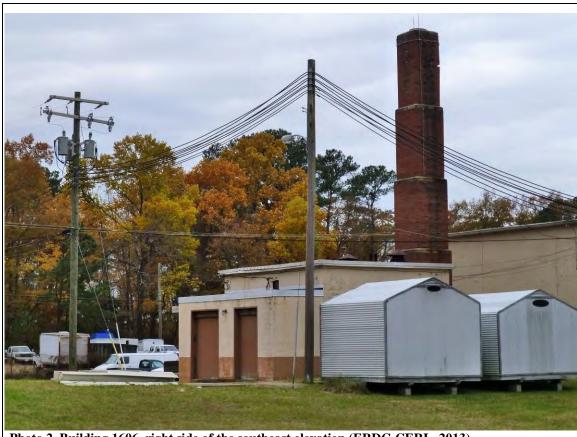
Photo 2. Building 1606, right side of the southeast elevation (ERDC-CERL, 2013).

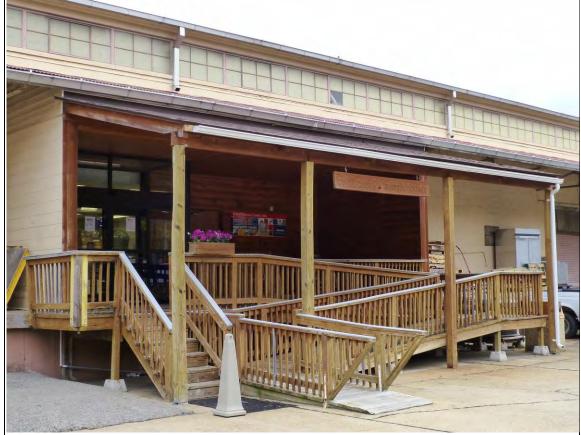
Photo 2. Building 1607, close-up of the modified entry on the southwest elevation (ERDC-CERL, 2013).

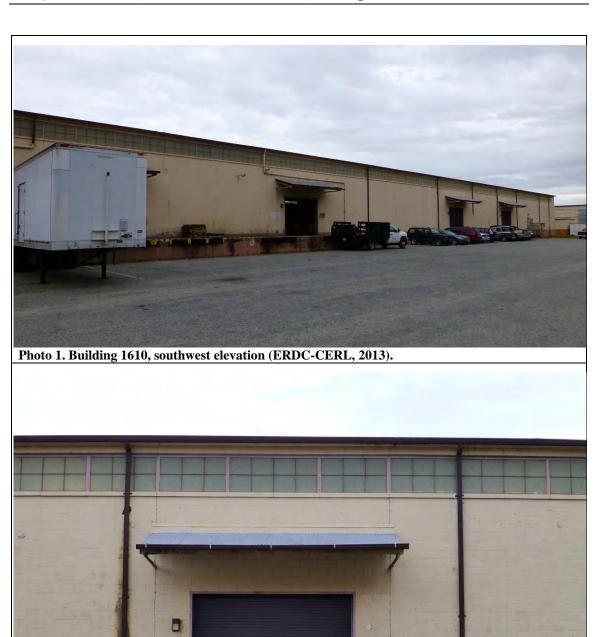
Photo 2. Building 1610, close-up of a bay on the southwest elevation (ERDC-CERL, 2013).

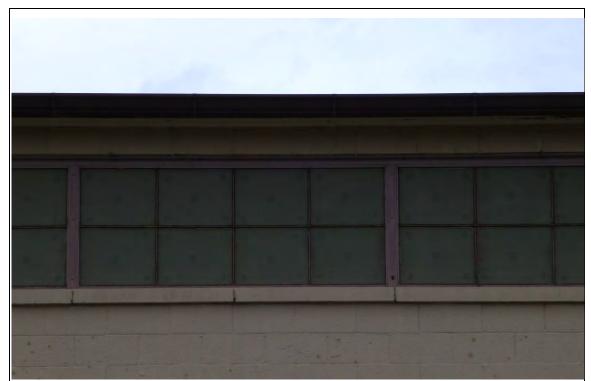
Photo 3. Building 1610, close-up of clerestory windows on the southwest elevation (ERDC-CERL, 2013).

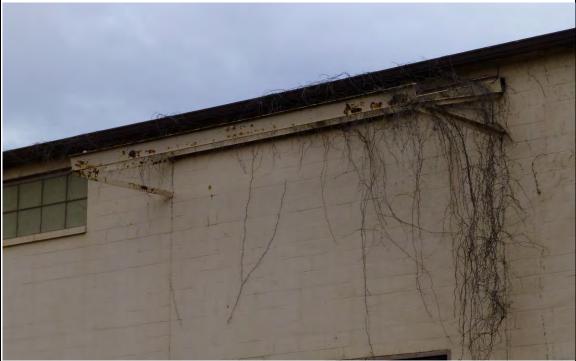
Photo 8. Building 1610, close-up of missing canopy structure over bay doors on the northeast elevation (ERDC-CERL, 2013).

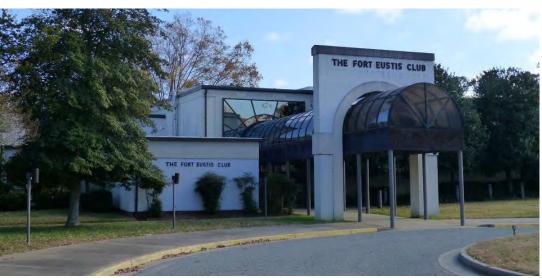
Photo 1. Building 2123, modified main entry on the northwest elevation (ERDC-CERL, 2013).

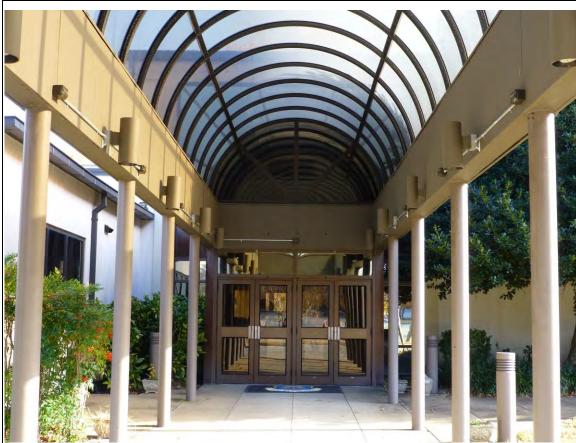
Photo 2. Building 2123, interior of modified main entry and canopy structure on the northwest elevation (ERDC-CERL, 2013).

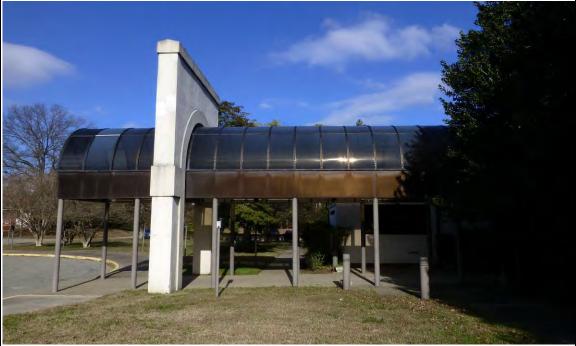
Photo 3. Building 2123, modified main entry on the northwest elevation (ERDC-CERL, 2013).

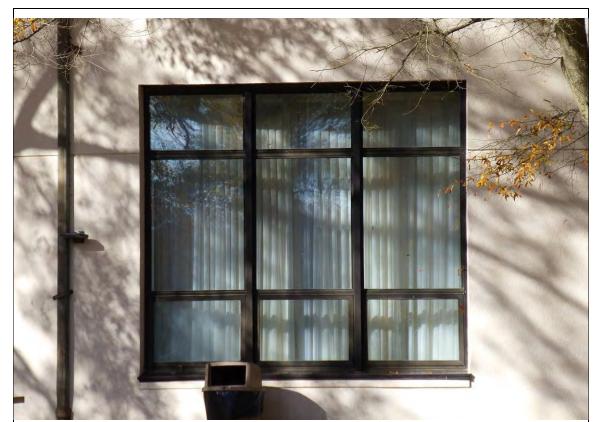
Photo 10. Building 2123, close-up of replacement window set within rotunda wall (ERDC-CERL, 2013).

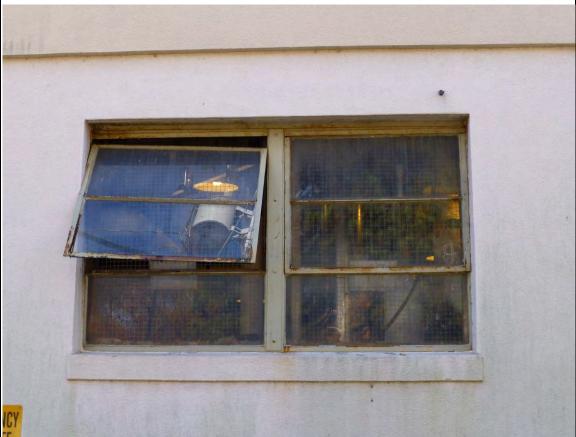
Photo 13. Building 2123, original steel awning windows on the northeast wall (ERDC-CERL, 2013).

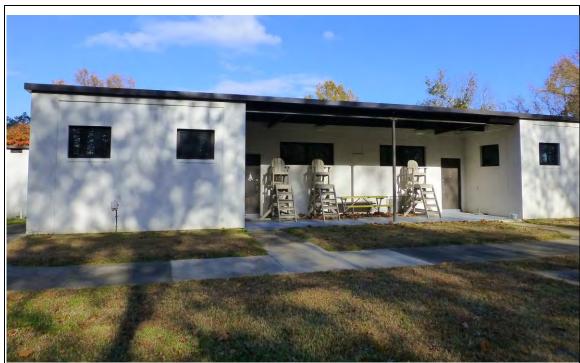
Photo 4. Building 2124, southwest elevation incised porch area (ERDC-CERL, 2013).

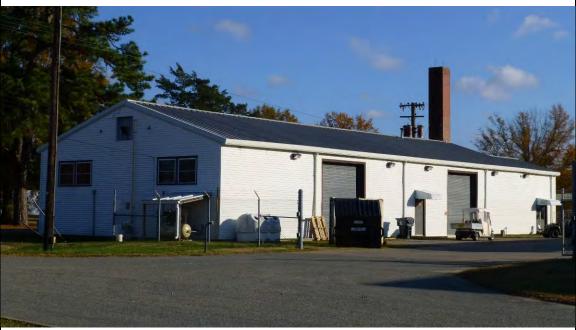
Photo 1. Building 2504, northwest oblique (ERDC-CERL, 2013).

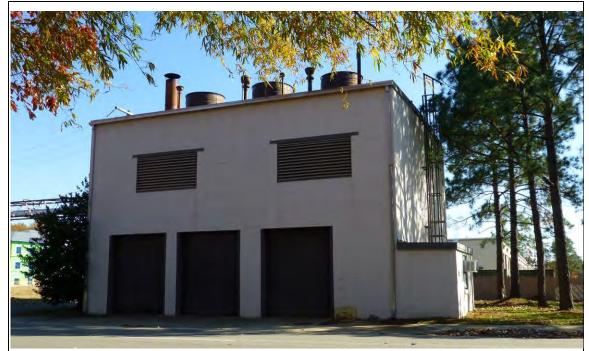
Photo 1. Building 2701, northwest elevation (ERDC-CERL, 2013).

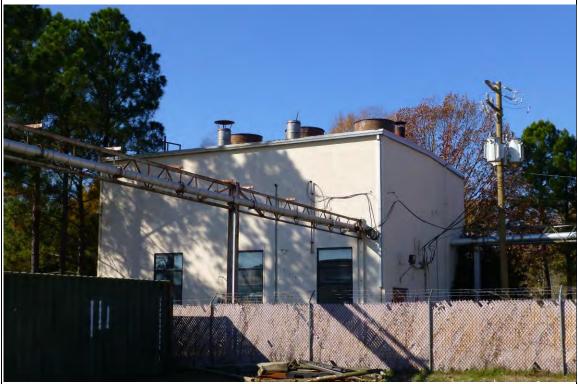
Photo 2. Building 2701, east oblique (ERDC-CERL, 2013).

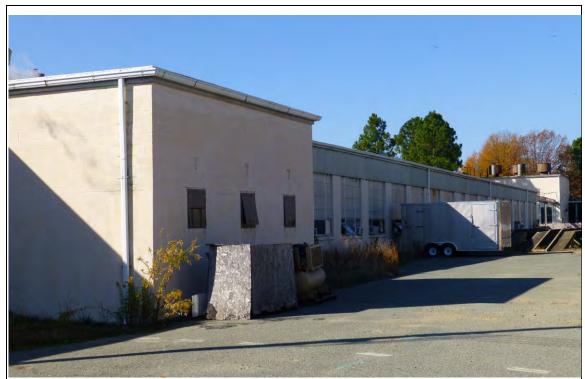
Photo 3. Building 2702, right side of the northeast elevation (ERDC-CERL, 2013).

The northeast elevation faces Marshall Street. There are two groups of elevated metal wash racks located on this side of the building; one group per high-bay section. There are nineteen groups of replacement bright-aluminum windows located on both the left and right sides of the elevation. Corrugated fiberglass panels stretch across the top of the high-bay exterior walls. The two-story section has a one-story appendage that projects off of it. The appendage has a flat roof and three small window openings on the northeast wall, a set of metal doors on the southeast wall, and the only original multipane steel-sash awning window on the northwest wall of the appendage.

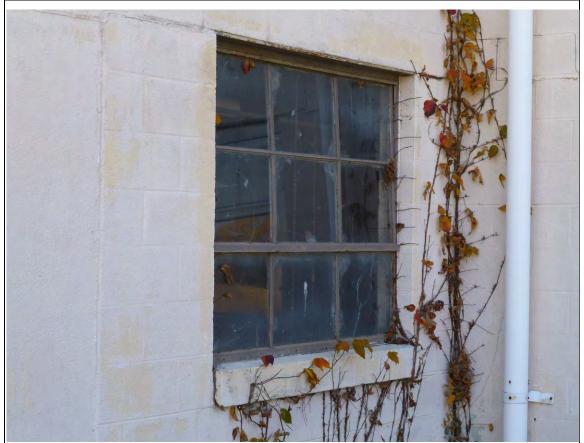
Photo 4. Building 2702, close-up of original steel multipane window located on the northwest side of the appendage that projects off of the northeast elevation (ERDC-CERL, 2013).

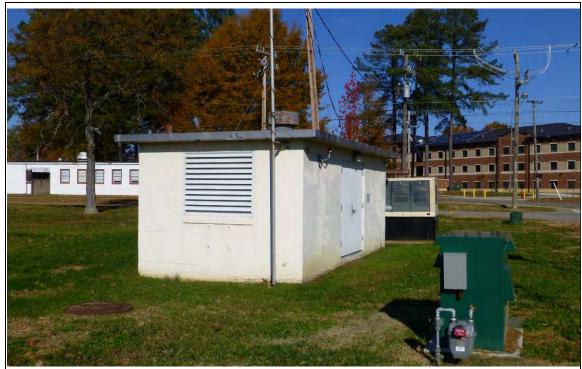
Photo 1. Building 2713, southeast oblique (ERDC-CERL, 2013).

The overall massing (flat roof with overhangs, rectangular footprint, and one-story) is intact; however, the style (concrete block/utilitarian) of Building 2713 has been altered through modifications to the building. At an unknown date(s), the doors were replaced, and the original steel multipane windows were removed and replaced with metal louvered vents.

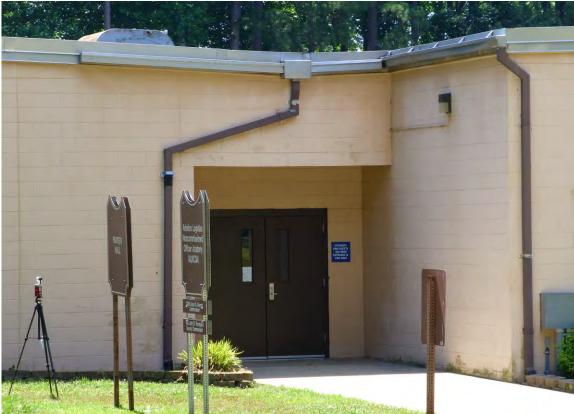
Photo 3. Building 2730, close-up of replacement recessed entry doors on the left side of the northwest elevation (ERDC-CERL, 2013).

The northwest (front) elevation faces Madison Avenue. The middle section of the elevation projects outward and is covered by the shallow gable roof. There are two recessed entry points that flank the middle section. The entries consist of a set of replacement metal doors.

The overall massing ("butterfly" roof, square footprint, one-story) and the style (concrete block/utilitarian) of Building 2730 are intact. The majority of the original construction materials (concrete block walls) are intact; the entry doors have all been replaced.

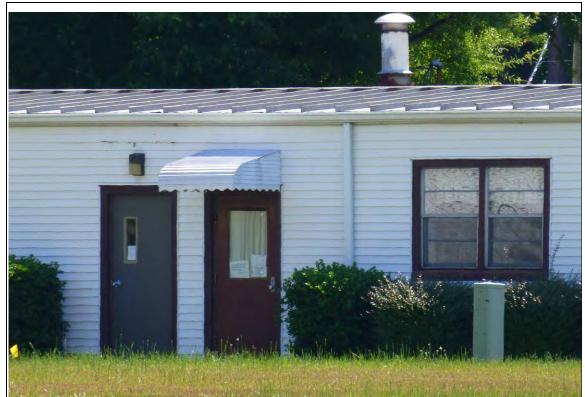
Photo 2. Building 2731, close-up of the replacement doors on the northwest elevation (ERDC-CERL, 2014).

The overall massing (gable roof, T-shaped footprint, one-story) of Building 2731 is intact, but the style has been altered through modifications to the building. In 1985, vinyl siding was applied over the original metal exterior cladding material. At an unknown date(s), the original windows and doors were replaced.

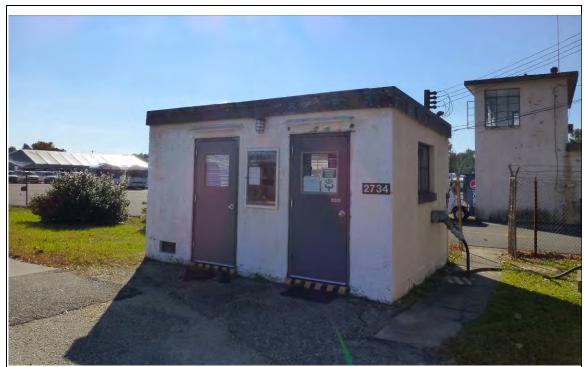
Photo 1. Building 2734, northeast oblique (ERDC-CERL, 2013).

The northeast (front) elevation faces a paved lot and consists of two single-entry replacement metal doors.

At an unknown date, the doors on the northeast elevation were replaced with newer metal doors.

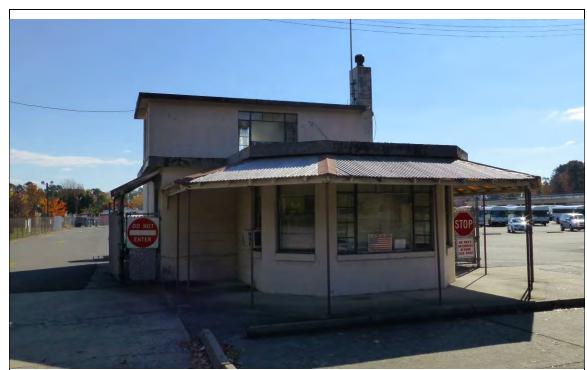
Photo 2. Building 2735, northwest elevation, close-up of canopy (ERDC-CERL, 2013).

At an unknown date(s), a metal canopy structure was added to the northwest (front) elevation, and the single-entry door on the southeast elevation was replaced.

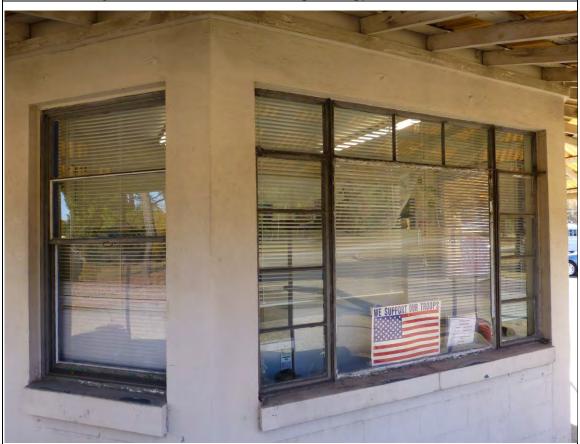
Photo 3. Building 2735, close-up of original windows on the northwest elevation (ERDC-CERL, 2013).

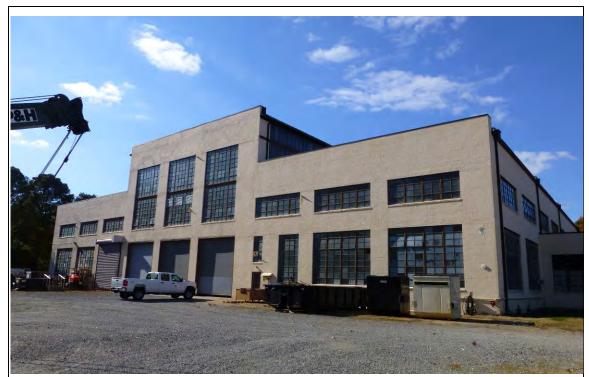
Photo 2. Building 2750, east elevation (ERDC-CERL, 2013).

The right side of the east elevation is where the one-story portion of the building is located. This section of the elevation is recessed and consists of two groups of original windows. The remainder of the east elevation is the high-bay/monitor section flanked on either side by the two-story areas. The left side two-story area consists of two large groups of original industrial windows and a replacement overhead garage door on the first level and three strips of original industrial windows evenly spaced across the second level. The right side two-story area consists of two large groups of original industrial windows, an individual original window, and replacement entry door on the first level and three strips of original industrial windows evenly spaced across the second level. The high-bay middle section of the east elevation is three-bays wide and consists of three replacement overhead garage doors topped with three large groups of original windows.

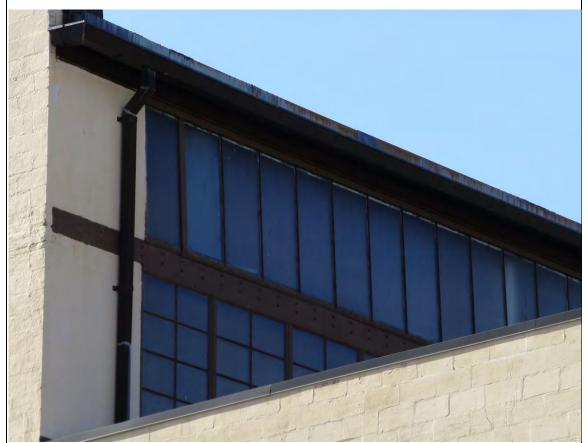
Photo 3. Building 2750, close-up of original steel multipane windows on the north side of the monitor roof (ERDC-CERL, 2013).

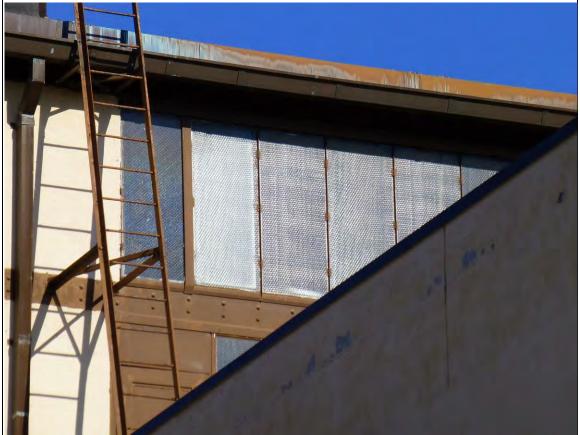
Photo 5. Building 2750, close-up of the original windows on the left side of the south elevation of the monitor roof (ERDC-CERL, 2013).

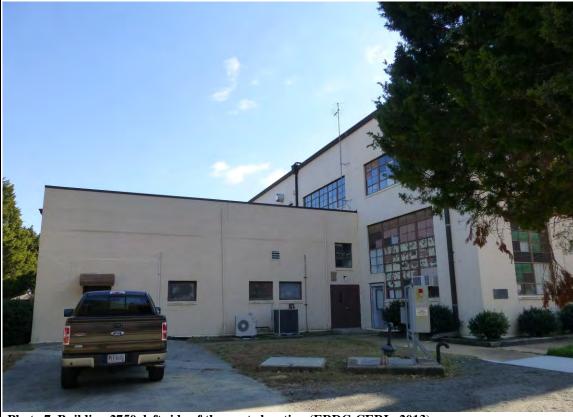
Photo 7. Building 2750, left side of the west elevation (ERDC-CERL, 2013).

The far left side of the west elevation is where the one-story portion of the building is located. Two large original windows were removed and the openings filled mostly with concrete block, a single-entry door, and three small windows. There is also a set of metal entry doors located on this part of the elevation. The middle section of the west elevation is the high-bay/monitor roof section that is flanked on either side by two-story areas. The high-bay section is defined by railroad tracks that terminate inside the building. One large replacement overhead door and two smaller replacement overhead doors are entry points for the railroad tracks. Three large groups of original industrial windows are located above these doors. The two-story areas that flank the high-bay section are dotted with a combination of strips of original industrial windows, large groups of original industrial windows, and individual windows. A one-story appendage projects off the left-side two-story area.

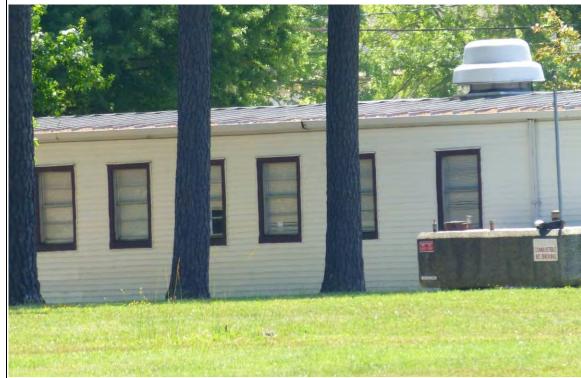
Photo 3. Building 2751, close-up of replacement windows on the north elevation (ERDC-CERL, 2014).

The building has undergone renovations since its original construction and design. Originally the building has metal-clad exterior walls that have since been removed and replaced with vinyl siding. The original windows were metal-sash and have since been removed and replaced with the current one-overone double-hung windows with a metal surround. The original roof was removed and replaced with the current metal channel roofing material.

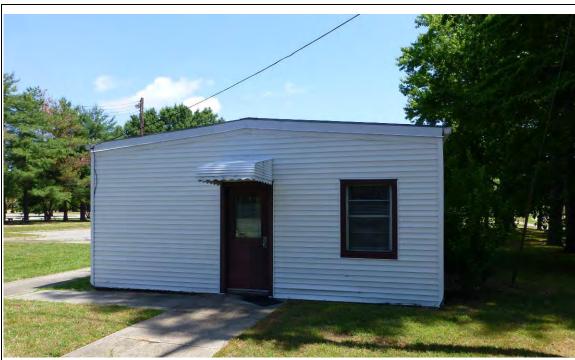
Photo 2. Building 2783, southwest elevation (ERDC-CERL, 2014).

The southwest elevation faces a small paved lot. There are eleven replacement windows, a single-entry replacement door with metal awning, and a set of replacement metal service doors on this elevation.

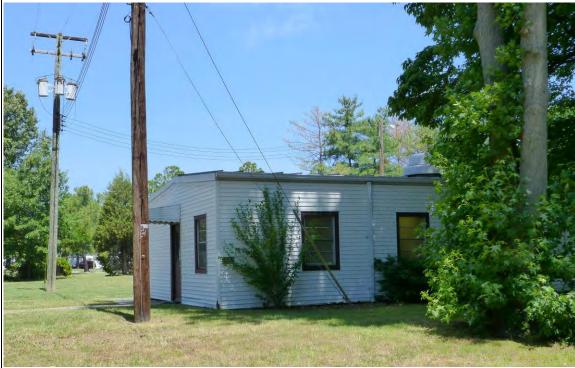
Photo 3. Building 2783, left side of the southeast elevation (ERDC-CERL, 2014).

The southeast elevation has a single-entry replacement door with a metal awning above and a single replacement window located to the right of the door.

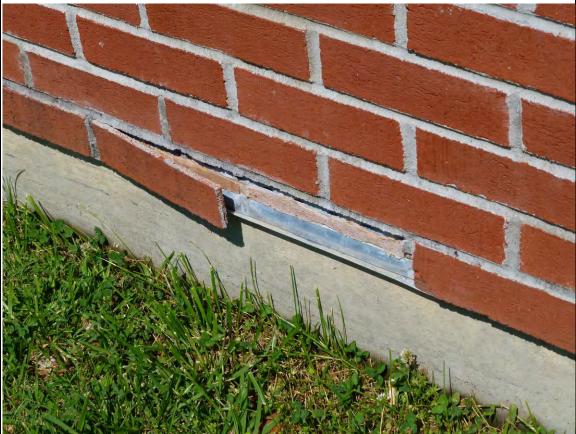
Photo 5. Building 2788, close-up of the brick veneer used on the bottom portion of the exterior walls (ERDC-CERL, 2014).

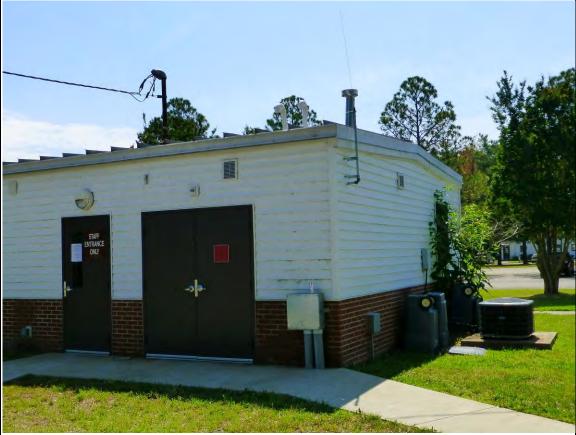
Photo 7. Building 2788, right side of the northwest elevation and the southwest elevation (ERDC-CERL, 2014).

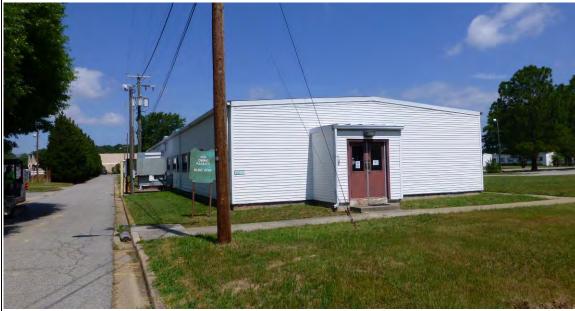
Photo 3. Building 2799, southeast elevation (ERDC-CERL, 2014).

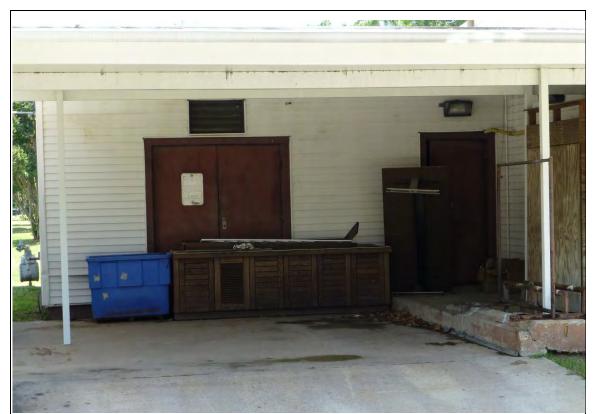
Photo 8. Building 2799, close-up of the covered loading area on the left side of the southwest elevation (ERDC-CERL, 2014).

The southwest elevation faces Harrison Loop. The left side of the elevation is where the covered loading area is located. A metal canopy projects over a concrete pad. A set of doors and a single door are located under this canopy. There are eleven paired replacement windows and one single replacement window spaced across the exterior wall. A small projecting vestibule area with a single-entry door is located in the middle of the elevation.

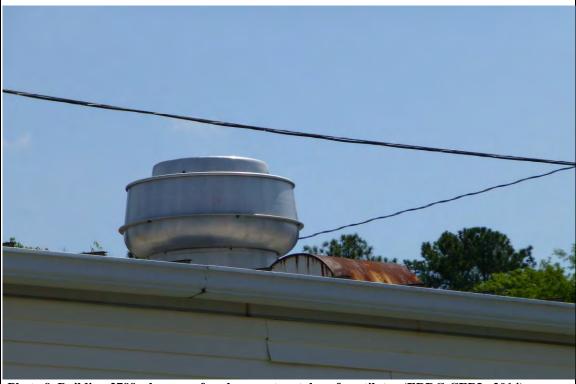
Photo 9. Building 2799, close-up of replacement metal roof ventilator (ERDC-CERL, 2014).

The overall massing (shallow gable roof, rectangular footprint, one-story) of Building 2799 is intact, but the style of the building has been altered through modifications to the building. All of the original construction materials have been removed and replaced with newer materials (vinyl siding, replacement windows, replacement entry doors, and replacement metal roof).

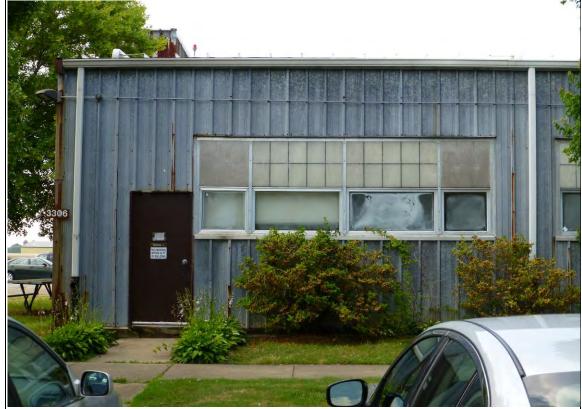
Photo 4. Building 3306, close-up of replacement entry door on the north elevation (ERDC-CERL, 2014).

The overall massing (rectangular footprint, high-bay with gable roof, one-story with shed roof) of Building 3306 is intact but the style (metal/hangar) of the building has been slightly altered through modifications to the building. At an unknown date(s), the original windows were removed and replaced with the current bright-aluminum windows with fiberglass panels. The majority of the original entry doors have been replaced.

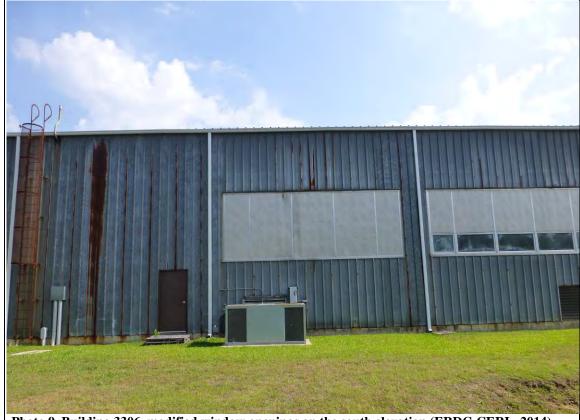
Photo 9. Building 3306, modified window openings on the south elevation (ERDC-CERL, 2014).

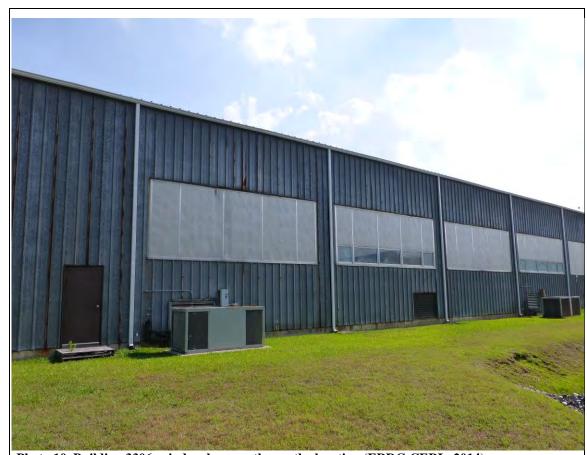
Photo 10. Building 3306, window bays on the south elevation (ERDC-CERL, 2014).

The south elevation is eleven bays wide. There are no windows in the far left or far right bays; there is only a single-entry door. The other nine bays each have a group of replacement windows.

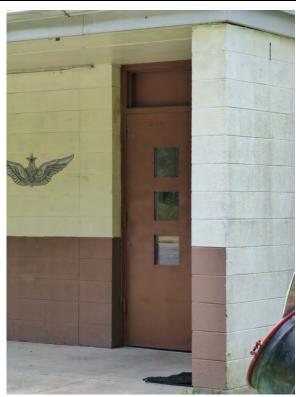
Photo 2. Building 3307, original metal and glass entry door on the east (front) elevation (ERDC-CERL, 2015).

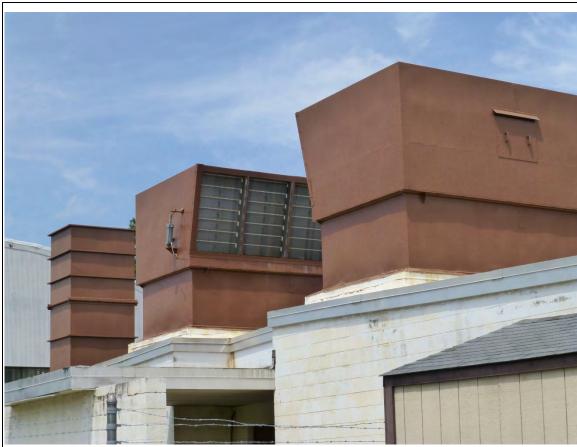
Photo 8. Building 3307, original metal vent roof stacks (ERDC-CERL, 2015).

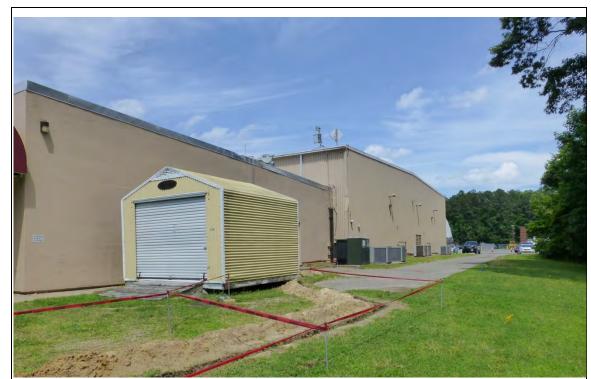
Photo 2. Building 3308, south elevation (ERDC-CERL, 2015).

The south elevation is two-part. The right side of the elevation is the original high-bay structure. There are no window or door openings on this part of the wall. The left side is the later, one-story addition. There is a recessed entry with replacement doors and a canvas canopy structure on this part of the wall.

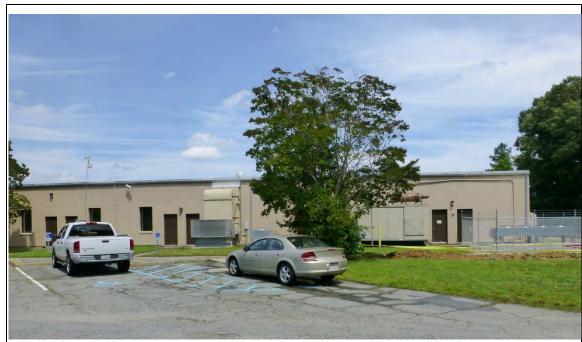
Photo 4. Building 3308, west elevation (addition) (ERDC-CERL, 2015).

One addition was constructed on the west side of the original structure. Even since its construction, this addition has undergone changes to include new replacement doors and modified exterior cladding material. Stucco-like material was added over the original exterior walls. New window openings have been added on the west side of the addition.

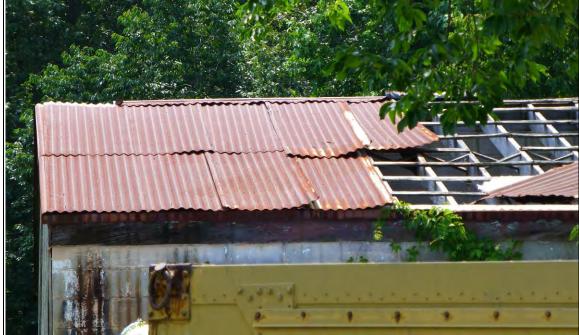
Photo 5. Building 3510, close-up of metal sheet roof (ERDC-CERL, 2014).

The overall massing (gable roof, rectangular footprint, one-story) of Building 3510 is intact, but the style of the building has been altered through modifications to the building. The majority of the original construction materials are in poor condition. The majority of the metal sheet-covered roof is missing.
